Features

CARBON HP 2-05 CHA

Technical data sheet

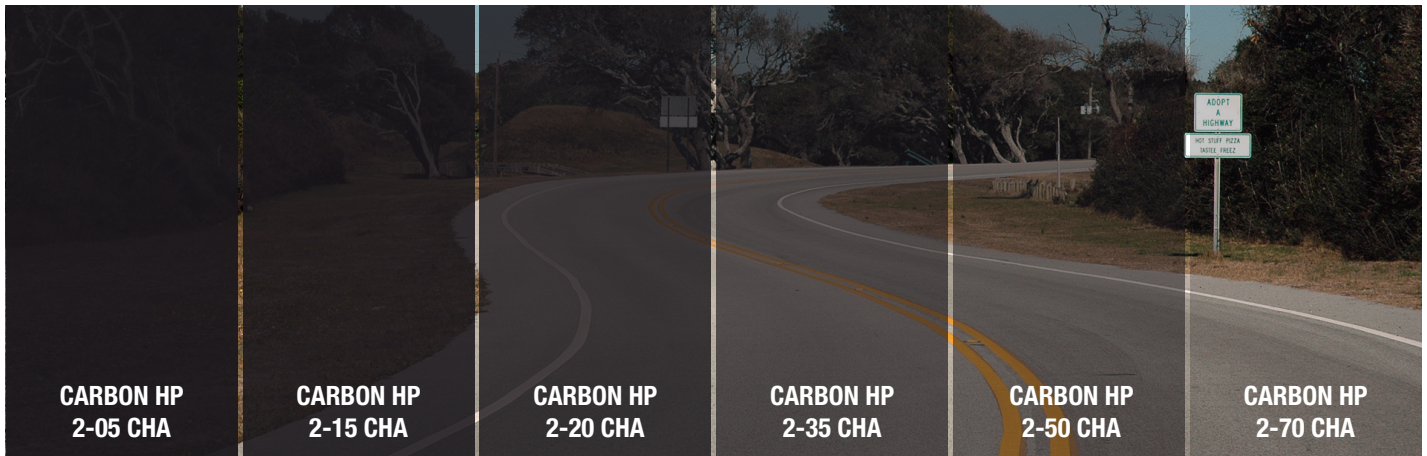
**CARBON HP
2-05 CHA**

**CARBON HP
2-15 CHA**

**CARBON HP
2-20 CHA**

**CARBON HP
2-35 CHA**

**CARBON HP
2-50 CHA**

**CARBON HP
2-70 CHA**
